**PROGRESS IN THE NONDESTRUCTIVE
EVALUATION OF CF-18 COMPOSITE
FLIGHT CONTROLS FOR WATER
INGRESS AND RELATED DAMAGE**

DCIEM Report No. 98 - TM - 44

Progress in the Nondestructive Evaluation of CF-18 Composite Flight Controls for Water Ingress and Related Damage

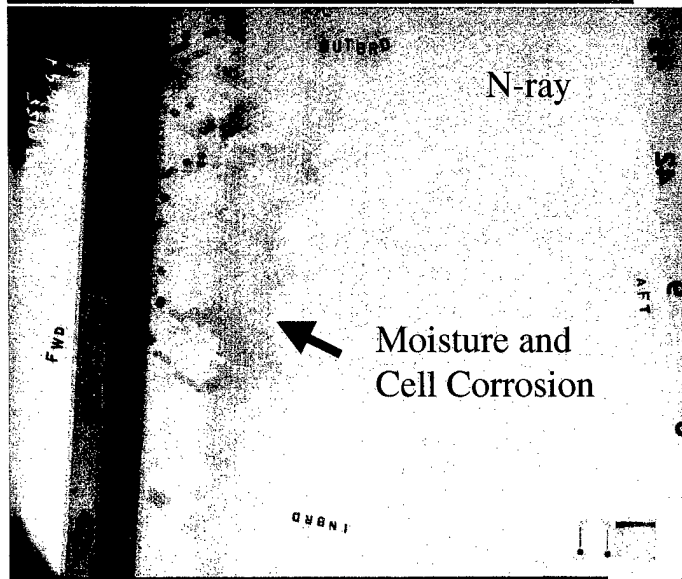
X-ray

Moisture and
Cell Corrosion

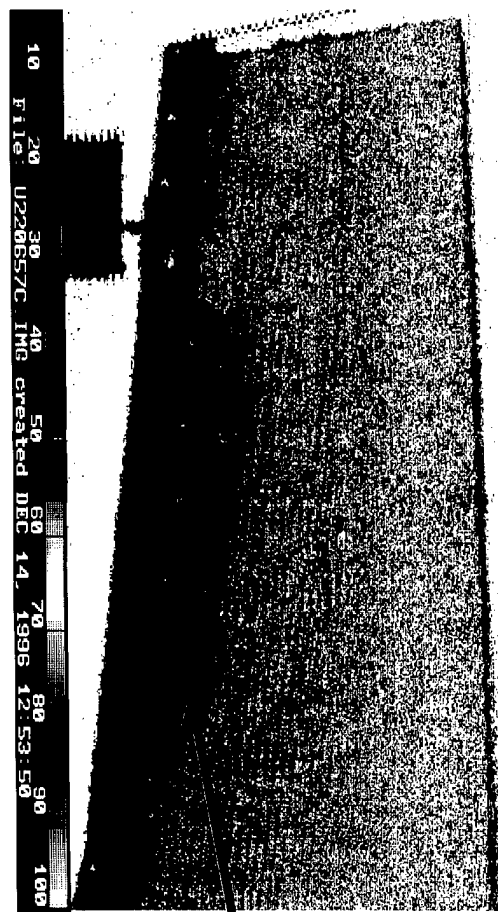
T.T. Ultrasound

Attenuation
indicates
Adhesive Disbond

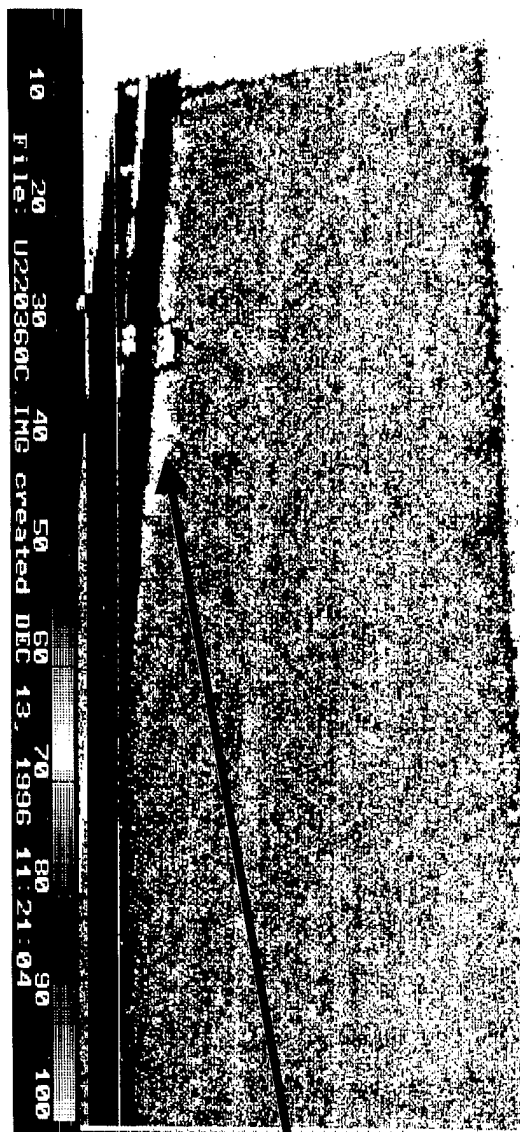
T.T. Ultrasound

Water filled cells
indicated by lower
attenuation (white)

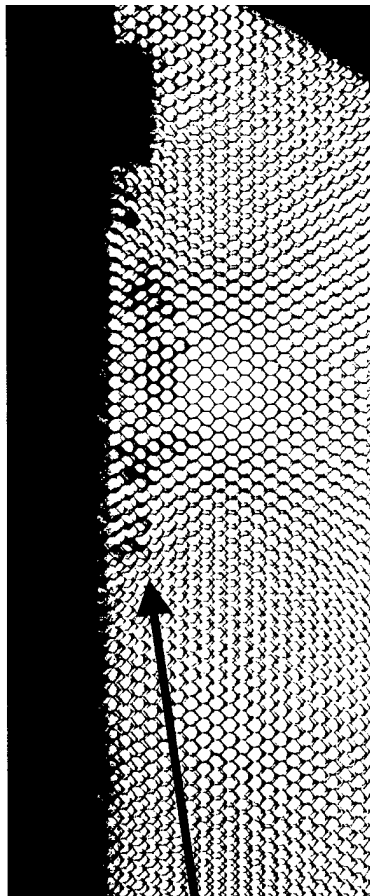
X-ray

Water Ingress

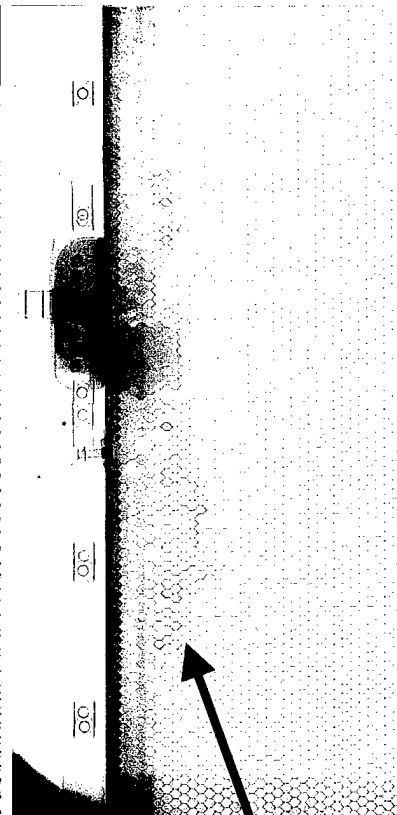
N-ray

Moisture / Water
Ingress
